## Appendix M Hydrology Studies

**Recent Erosion in the Baker Ranch Gully, Borrego Canyon Wash, Orange Co., CA**

**Channel Modification, Urbanization, and Channel Instability in Borrego Canyon  
Wash, Orange County, CA**

FIELD RESEARCH REPORT FOR SAN DIEGO CREEK CHANNEL STUDY  
1990

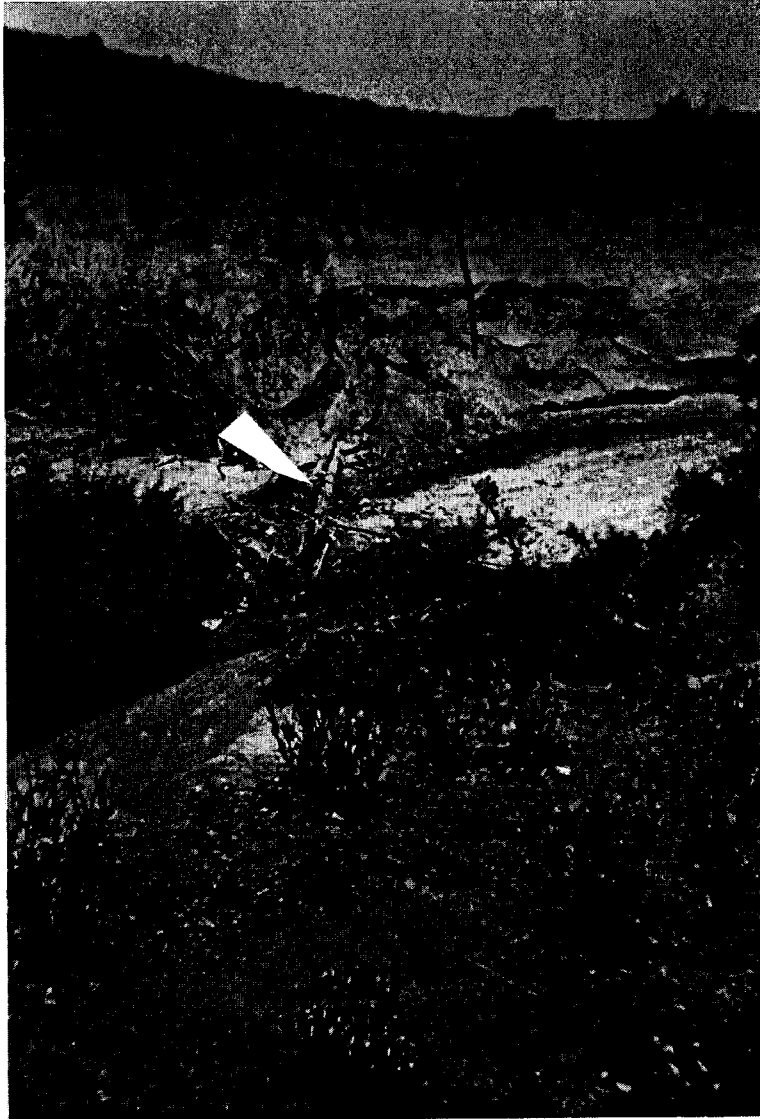
Figure 2. Debris dam of tree trunks (arrow) deflecting flow to the left bank (foreground). Approximately 300 feet (90 m) upstream of Profile X. Flow of stream is to the left.

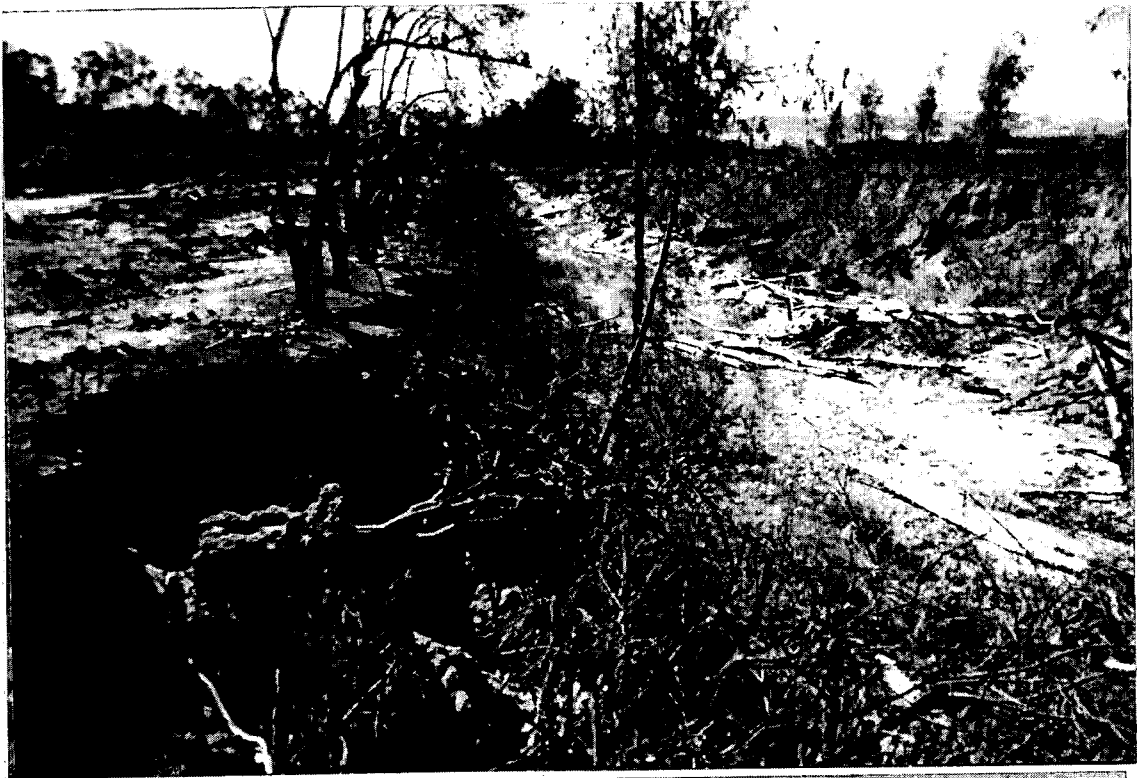
Figure 3. Channel widening at Profile X about 100 feet (30m) downstream of figure 2. View is looking downstream. A. 1998. Note U-shaped channel and dead trees on top of left bank in foreground. B. 2005. Note bank in foreground has been eroded away and that banks are much steeper.

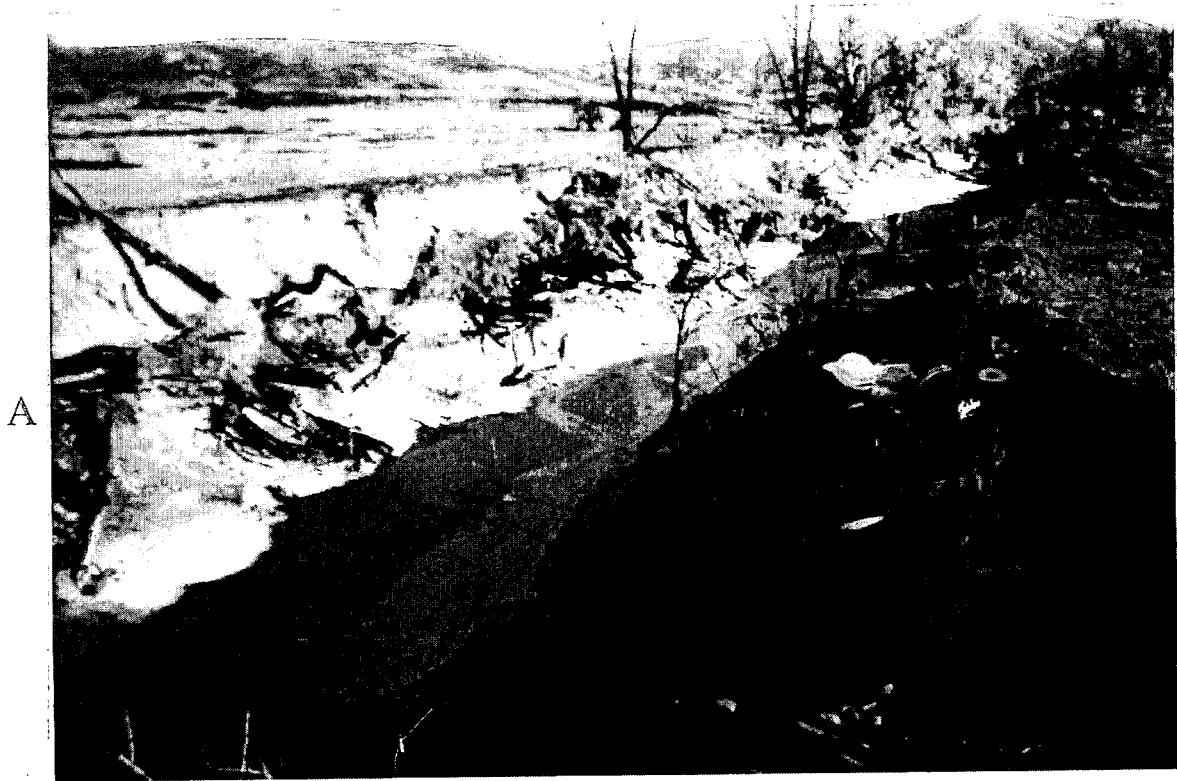
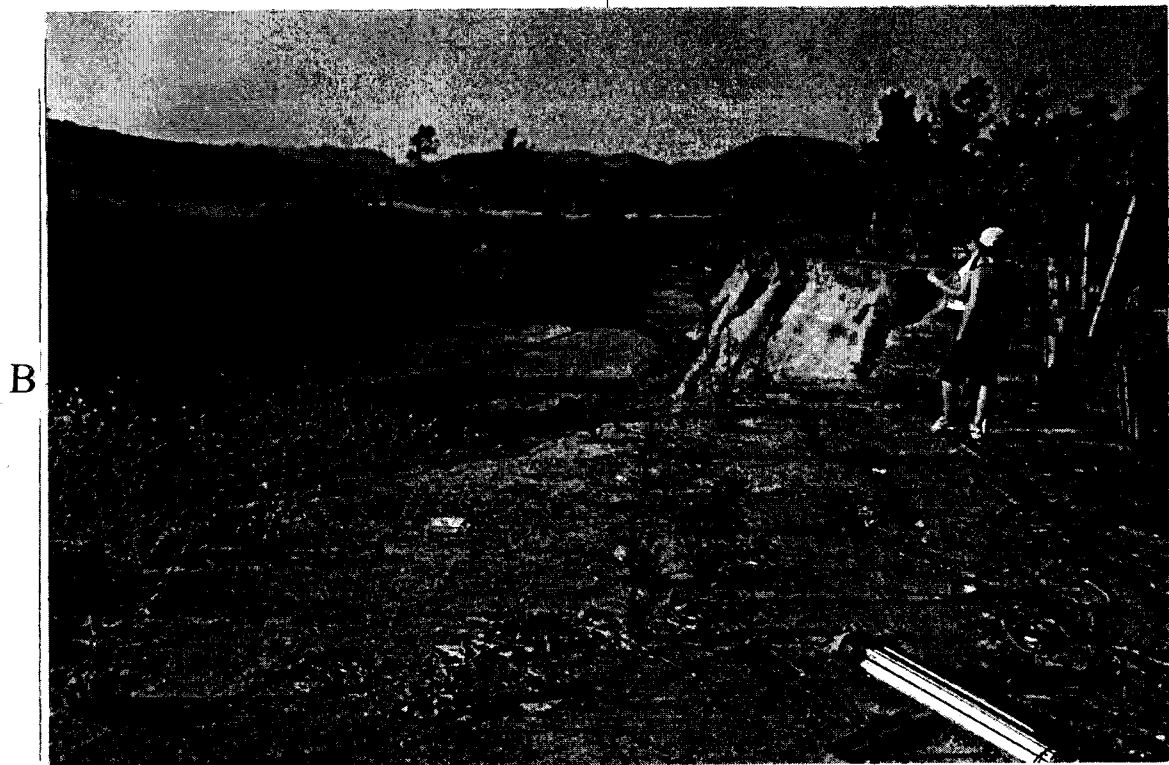
Figure. 4. Looking upstream near Profile 4AA. A. 1998. Note failed bank and tree trunks on far side (right bank). B. 2005. Note material on far bank has been removed by stream erosion and that the channel has been widened with steeper, high banks.

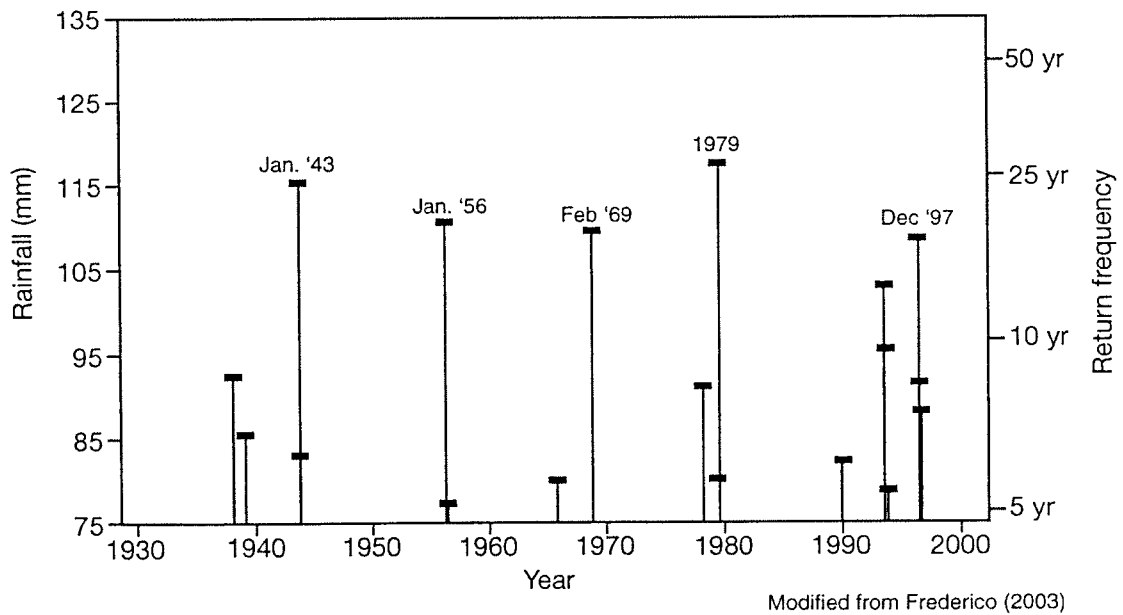
Figure 4

**Daily Rainfall > 75 mm -- Orange County Precipitation Stations #176  
and #130 (Approx. 3-4 km south of study area.  
Water Years 1928-2001  
(Note multiple single year peaks)**

structures at the lower end, decreasing the slope from 2.4% to 2.3%(Fig. 3). This combination proved to be relatively stable up to 1992 when urbanization was well underway and a wet period of greater rainfall began (Fig.4).

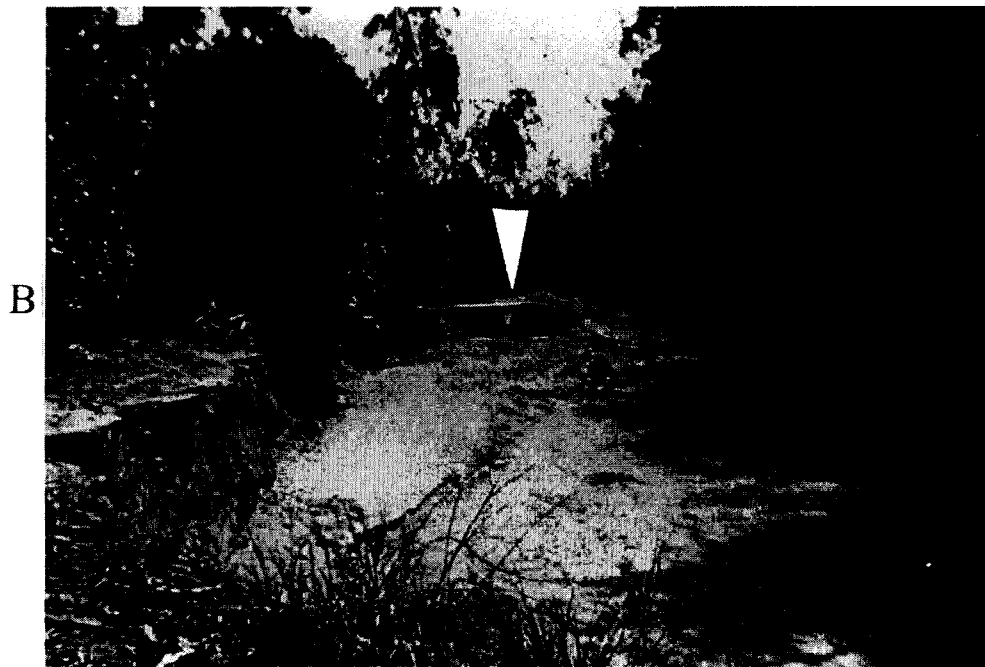
Figure 6. Looking downstream just below Profile 3. A. 1991. Note channel is still roughly trapezoidal. B. 1992. Channel has eroded the left bank by several meters removing the road and the first row of orange trees. The bank is 6 feet (2m) high. Note person standing by bank (arrow.)

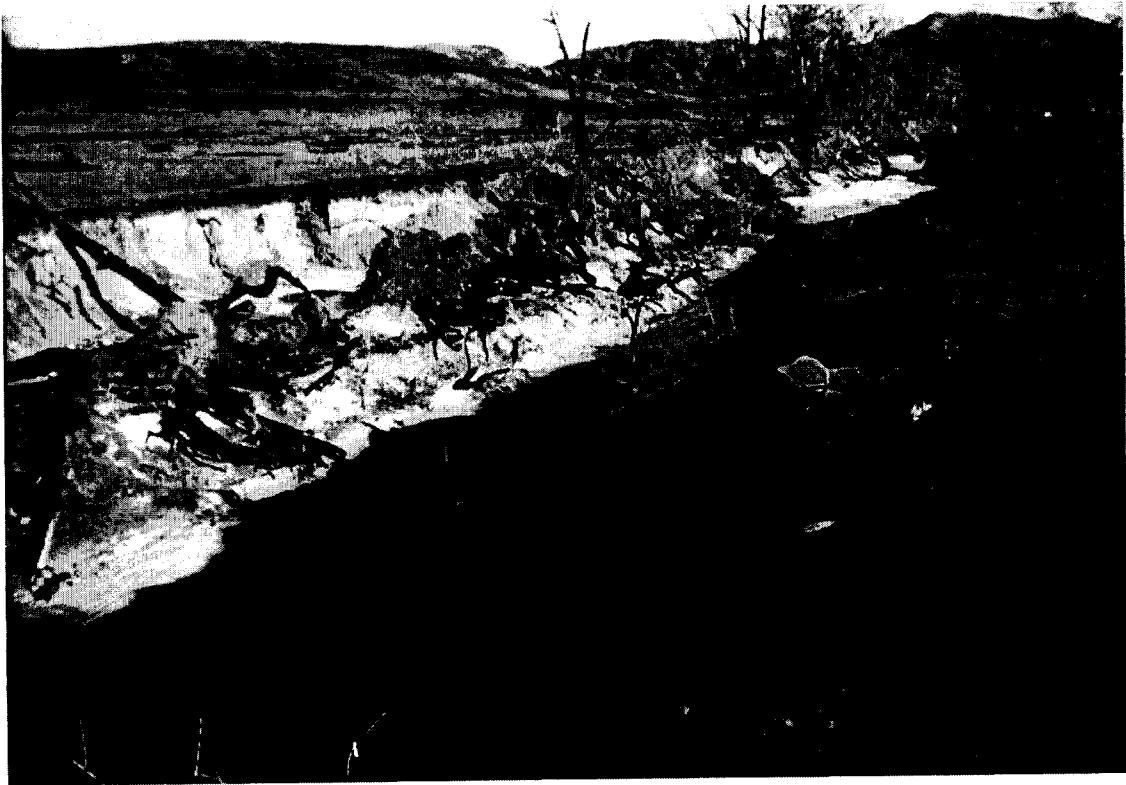
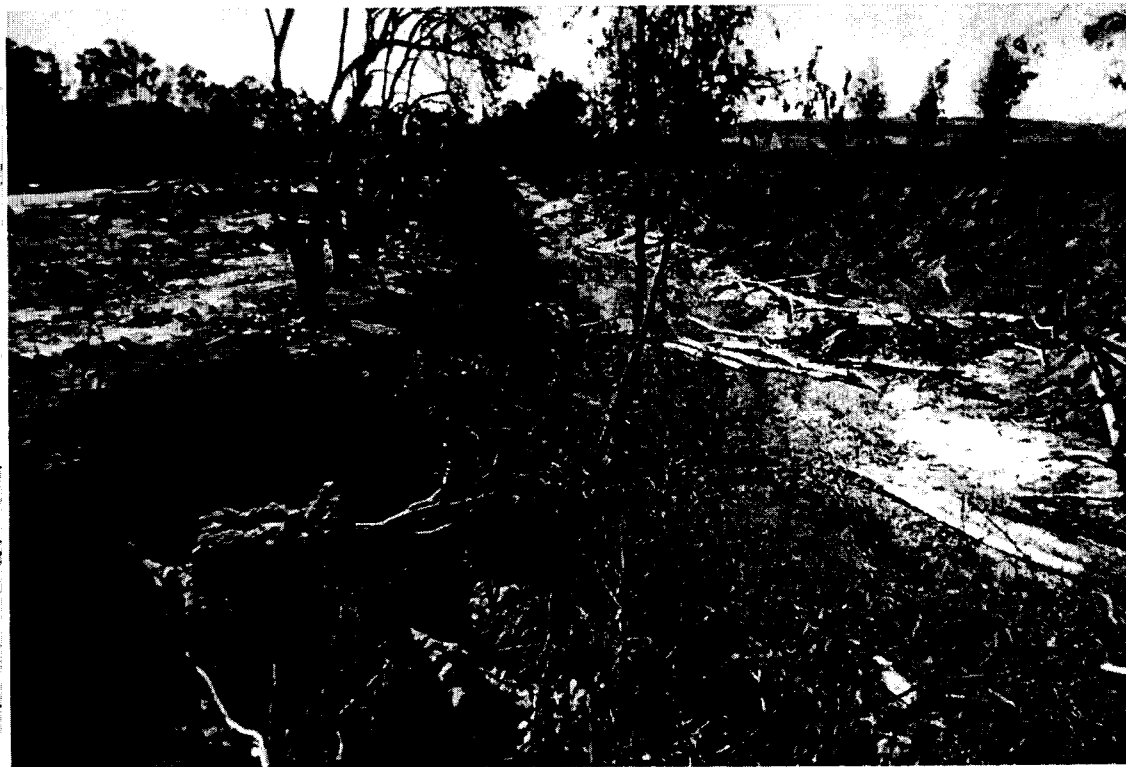
Figure 7. Incised channel upstream from drop structure, December, 1998. A. Looking upstream near Profile 4AA. Note failed bank on far side. B. Looking downstream near Profile X.

However, the 1997-98 storms washed out the downstream drop structure dropping the base level at least 4 feet (1.2 M). Vertical incision upstream moved rapidly and 2500 feet (800m) upstream had deepened to over 14 feet (4.3 m) during this single season. Further headward erosion was curtailed only by an indurated channel bottom where the new channel had been cut close to a hillside. The deep incision destabilized the wet banks, burdened as they were by mature eucalyptus trees, the high banks failed, and channel cross sections increased by a factor of up to ten (Figs.7 and 8).

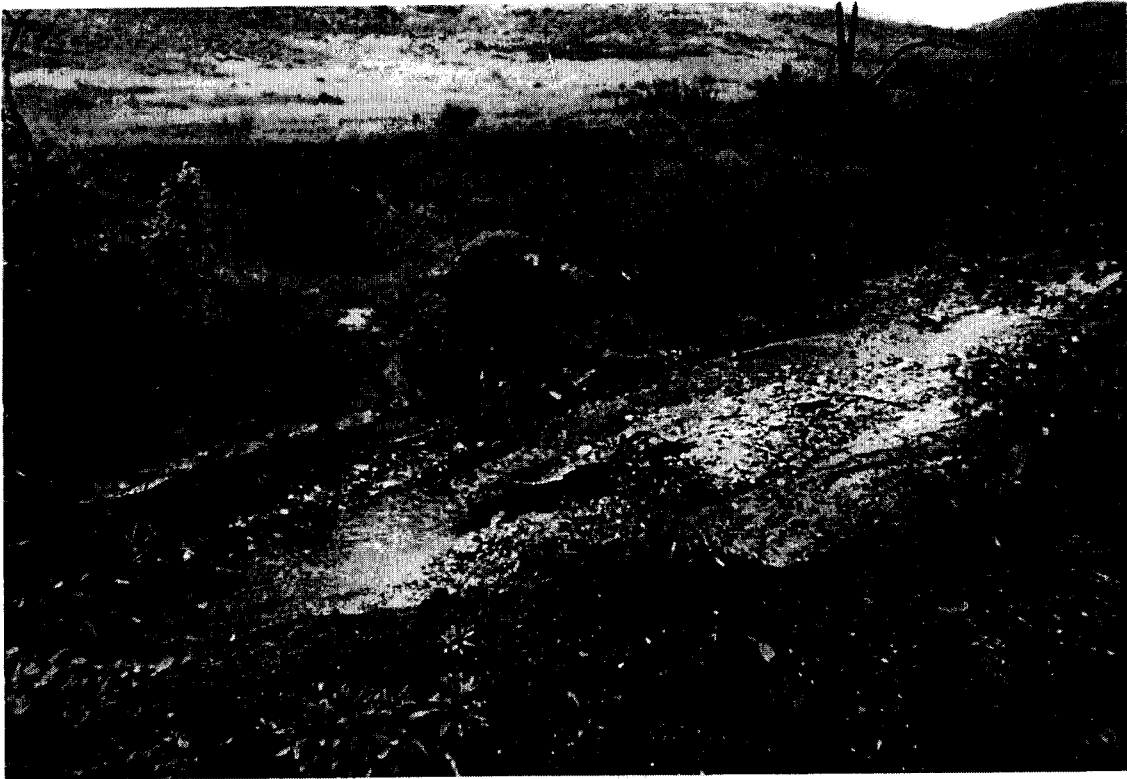
Figure 8. Incised channel upstream of drop structure, 2001. A. At approximate location of Figure 7A. The photo suggests further vertical channel erosion with further slumping of banks. B. Looking downstream near Profile 4 showing the narrow channel incised into the indurated material. Note superposed remnant of old channel bottom (arrow).

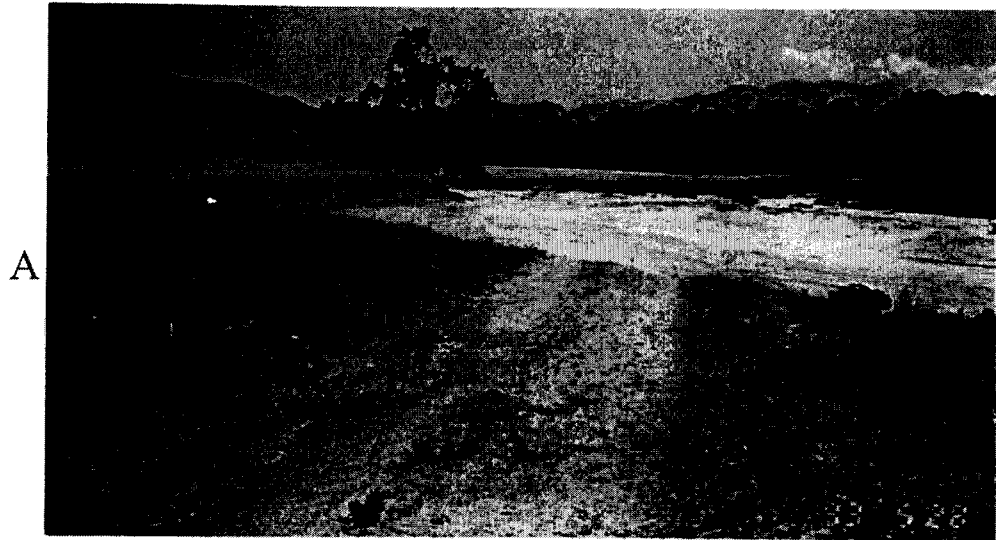
Figure 9. Photos along road looking upstream on right bank with photo position retreating as the result of bank erosion. For locations, see Fig. 5. For reference, note live oak to left on bank in A and B. In C, tree has been eroded away. A. 1992. B. 1993. C. 2003. Arrow in C. marks the road on far side.

Downstream in the reach below the drop structure, the 1992 flood breached the right bank which had been relatively stable since about 1952, making it retreat about 80 feet (24 m). The next year, 1993, another large area of floodplain was removed and again in 1998 (Fig. 5 and 9).

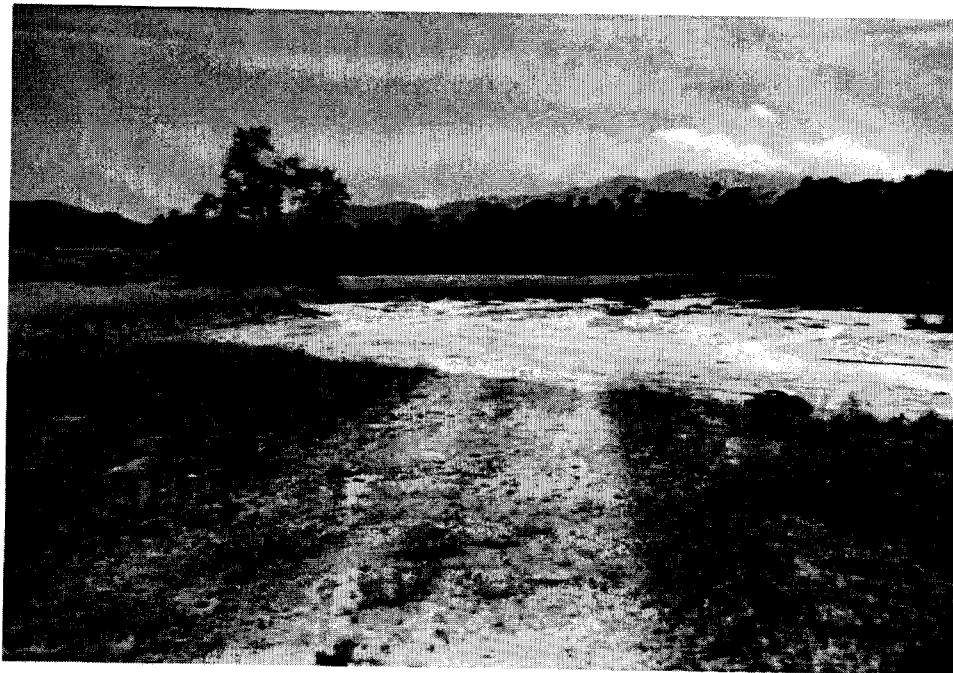
**Plate 3.** Severe Bank Erosion in Borrego Creek. A: 1992. Farm road in direct foreground recently went straight across the floodplain. Stormflows of water year 1991-1992 eroded away 50-100 feet of the floodplain. Note new farm road to left. Range 4A begins near tree to left. B: 1993. Bank has eroded another 50-75 feet and has almost undermined the tree.

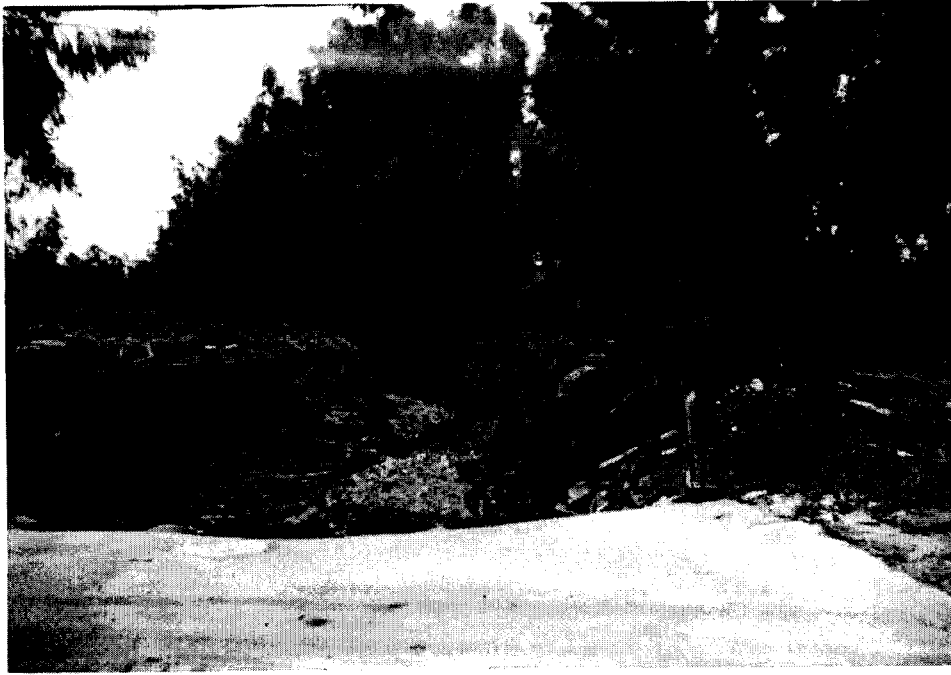
**Plate 4.** Channel Erosion from Urban Stormflow. Peters Canyon Wash 400 feet below Jamboree Road (F-3, Fig. 1). A: Looking downstream from road crossing and grade control structure. Undermining of this structure was prevented by reinforcement with rip-rap and concrete. B: About 400 feet downstream of photo A looking upstream. Note collapsed drop structure in channel and undermined bank. Range 4 is about 500' downstream.

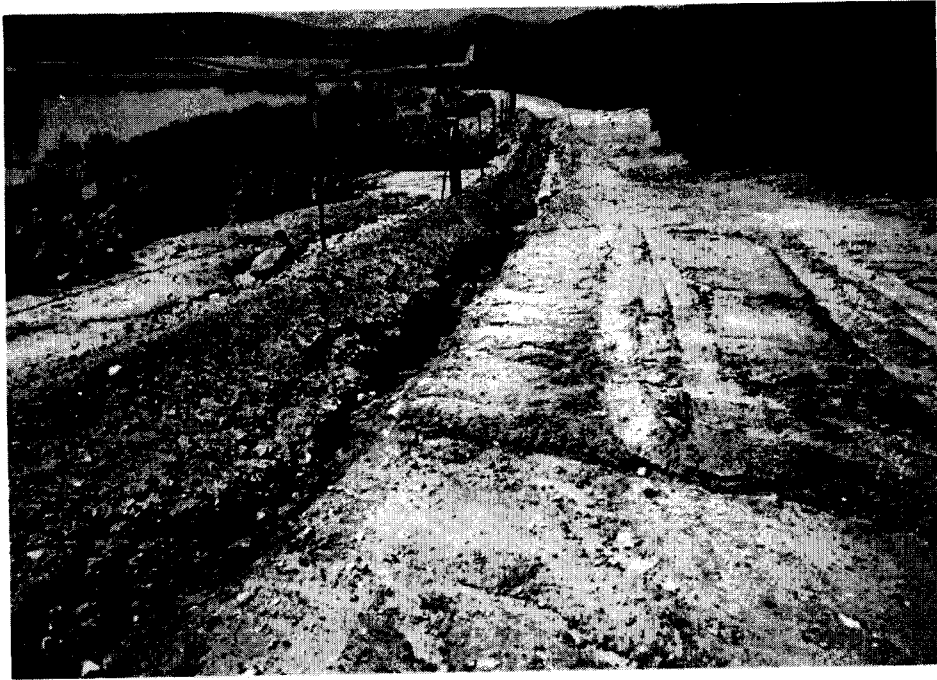
Plate 1. Eroded orchard slopes. Round Canyon looking downstream.

My general impression was that upland erosion was much more remarkable than channel erosion. Rills and small gullies on steep orchard slopes were common (Plate 1) whereas severe channel erosion was not common. This phenomenon probably relates to the intense but short duration of the rainfall received this Winter. It was severe enough to erode hillsides but the volume of runoff was just not adequate to generate high channel discharge and consequent erosion. Additionally, conditions may not have been wet enough to cause channel banks to be at their weakest and therefore most erosive condition.

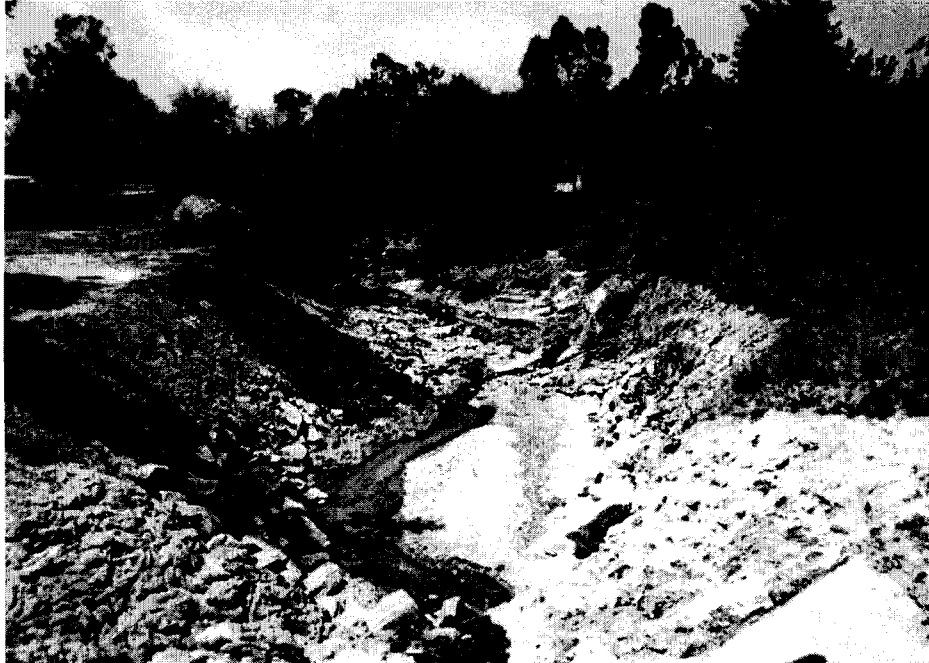
Plate 2. Dumping of loose soil along channel margins. Such material is easily entrained by floodwaters. Serrano Creek at Range 1A just downstream of Trabuco Road.

Material is still being dumped into channels. This is generally to rebuild eroded banks, but in some cases it appears that land is being developed at the expense of channel capacity (Plate 2). One last observation is that the channel of Kim Creek has been recently modified and reinforced with rip-rap. This improvement should assist in stabilizing this potentially erodible (Class 4) channel.

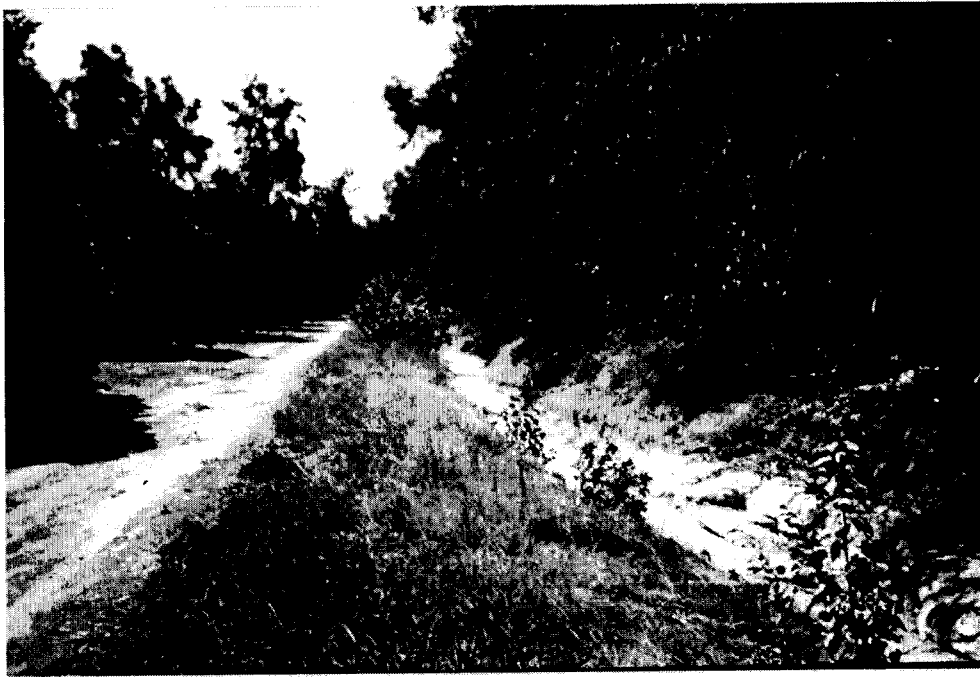
Plate 3. Severe bank erosion in Borrego Creek, looking downstream from urbanizing area. Note severe scouring in foreground. The toppled live oak lying in the channel bed marks Range 2 in the background.
